Maury Island Aquatic Reserve Shoreline Armoring Removal Monitoring Pre-Restoration Baseline 2016-2018

Perla, BS and Metler, MA. 2018. Maury Island Aquatic Reserve Shoreline Monitoring Pre-Restoration Baseline 2016-2018. Vashon Nature Center, Vashon, WA. 56 pp.

This Monitoring Report describes the research and monitoring study of shoreline bulkhead removal projects in Maury Island Aquatic Reserve. This project has been funded wholly or in part by the United States Environmental Protection Agency under assistance agreement PC-00J90701 through the Washington Department of Fish and Wildlife. The contents of this document do not necessarily reflect the views and policies of the Environmental Protection Agency or the Washington Department of Fish and Wildlife, nor does mention of trade names or commercial products constitute endorsement or recommendation for use.

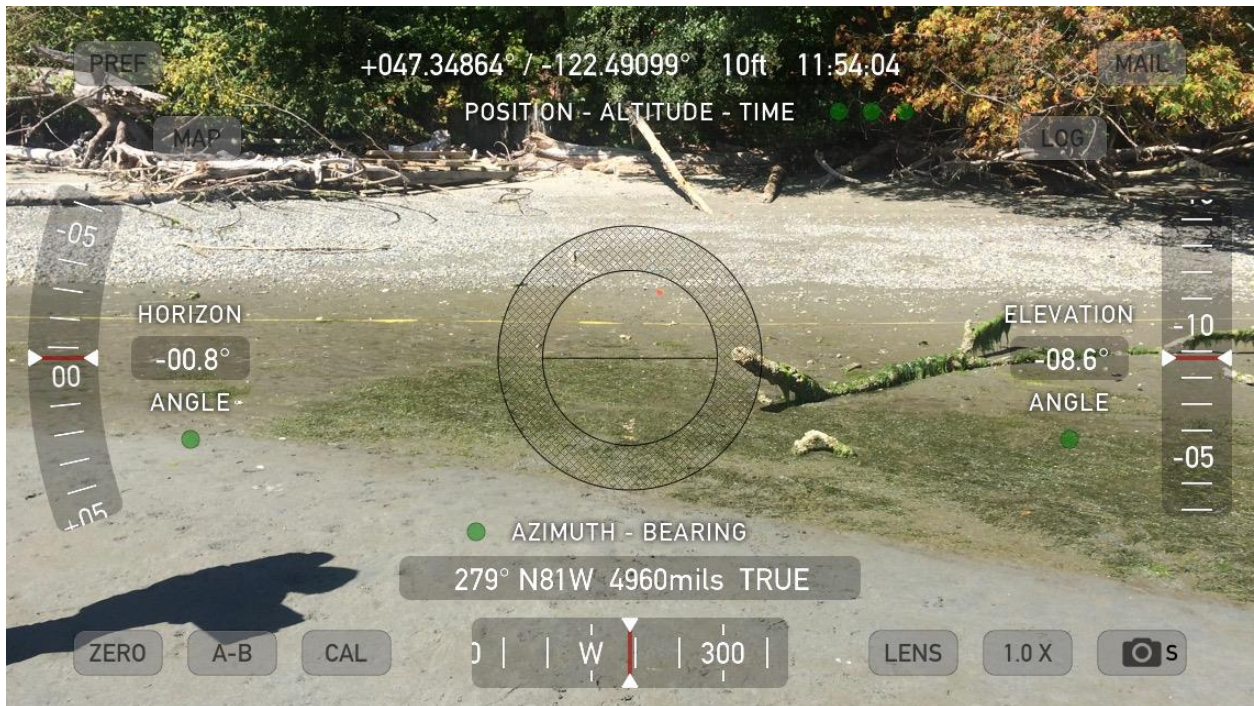
Figure 6b. Representative photo of the natural treatment at Forest Glen 2016.

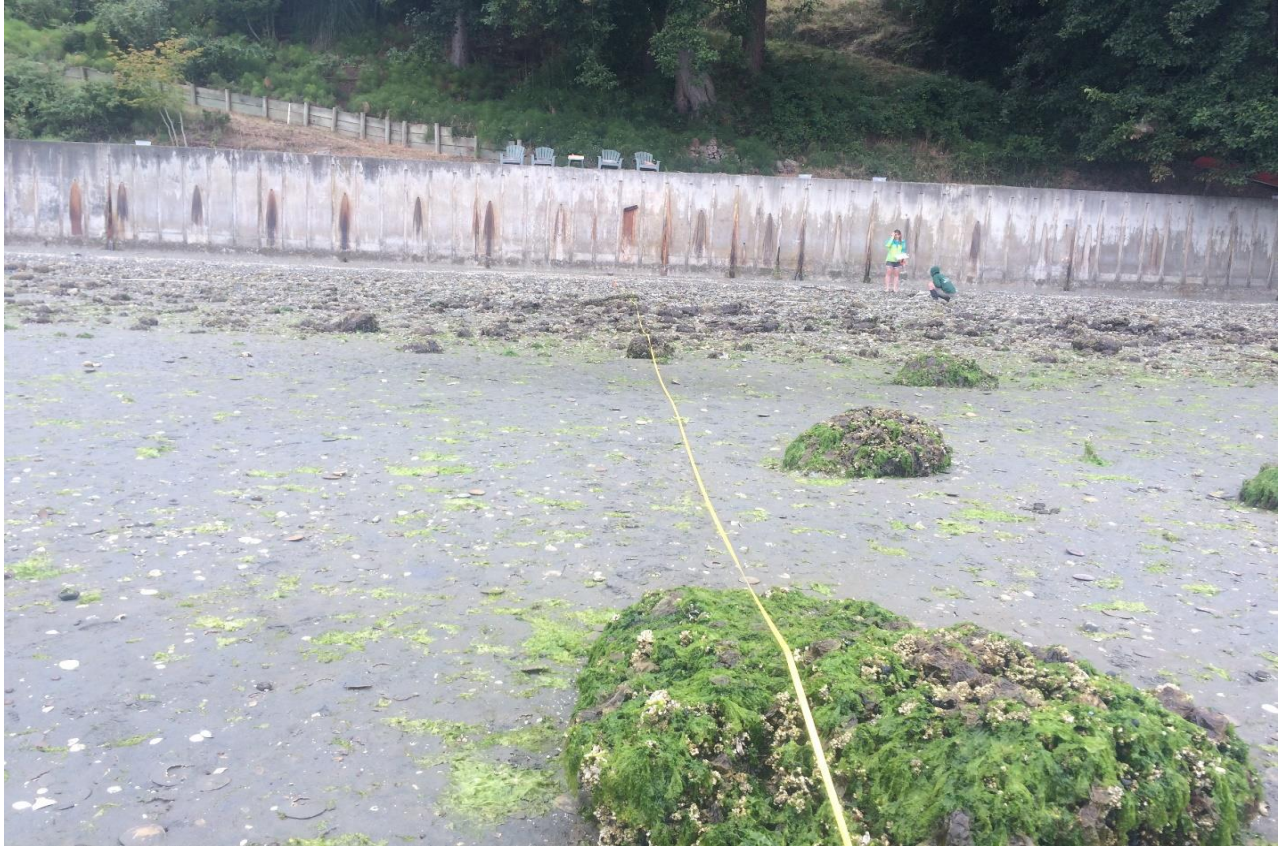
Figure 6 c. *Representative photo of the armored treatment at Forest Glen 2016.*

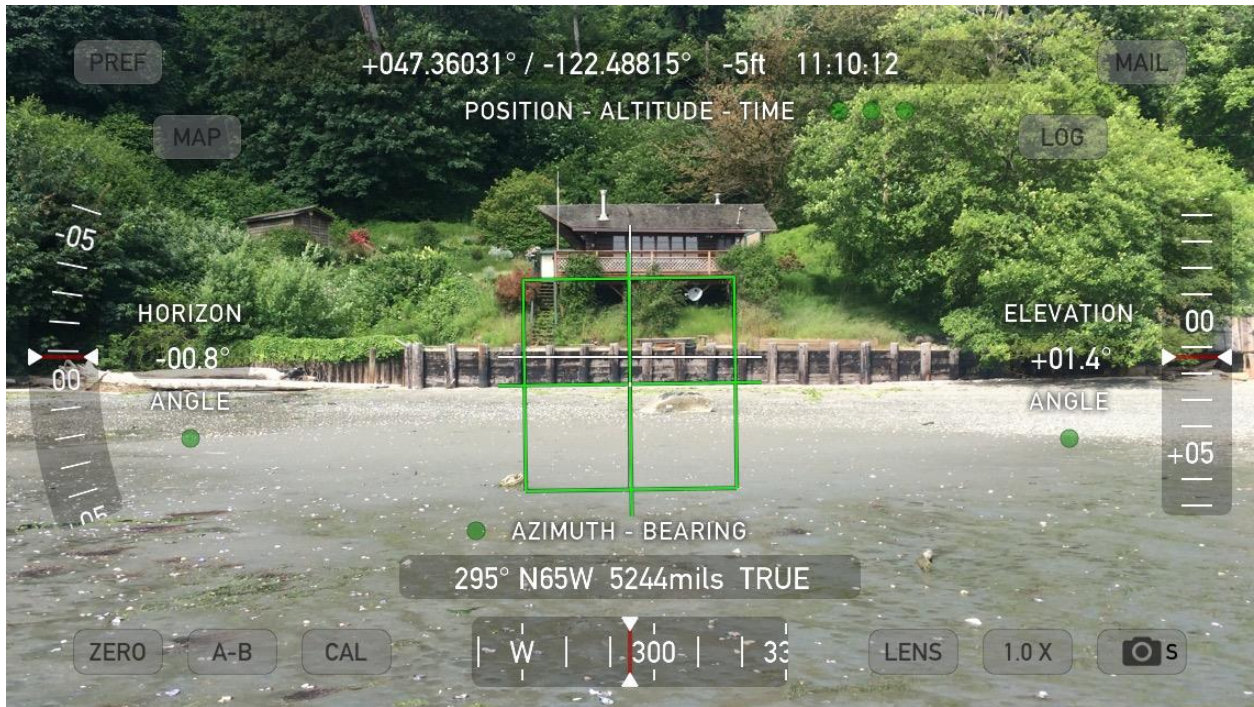
Figure 7a. *Lost Lake restoration treatment representative photo 2016.*

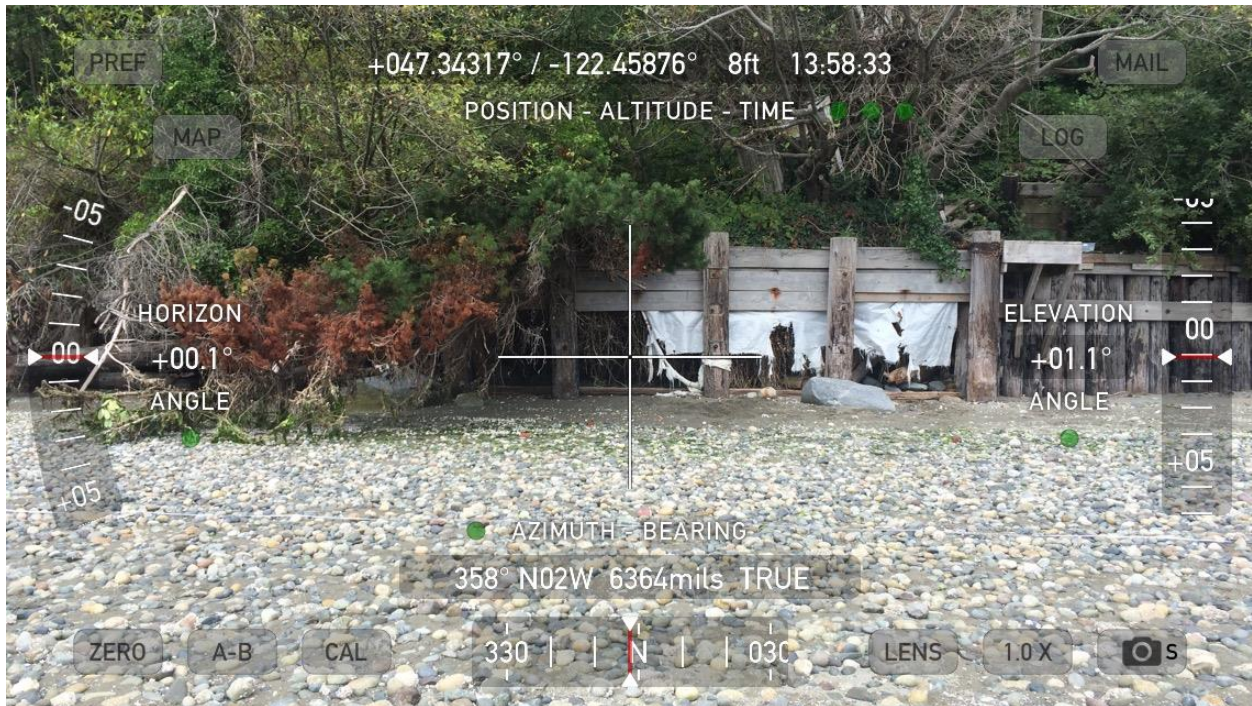
Figure 8a. Piner Point restoration site representative photo 2016.

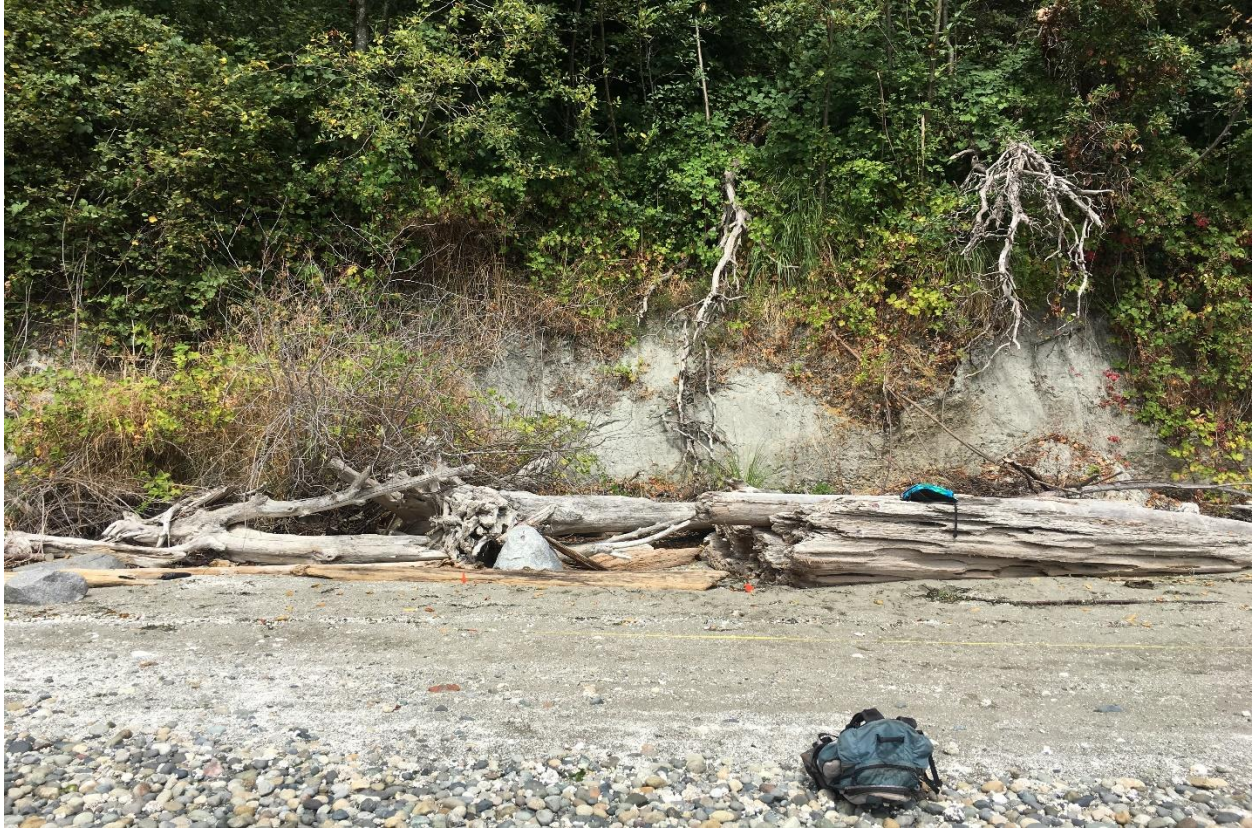
Figure 8b. Piner Point reference site representative photo 2017.

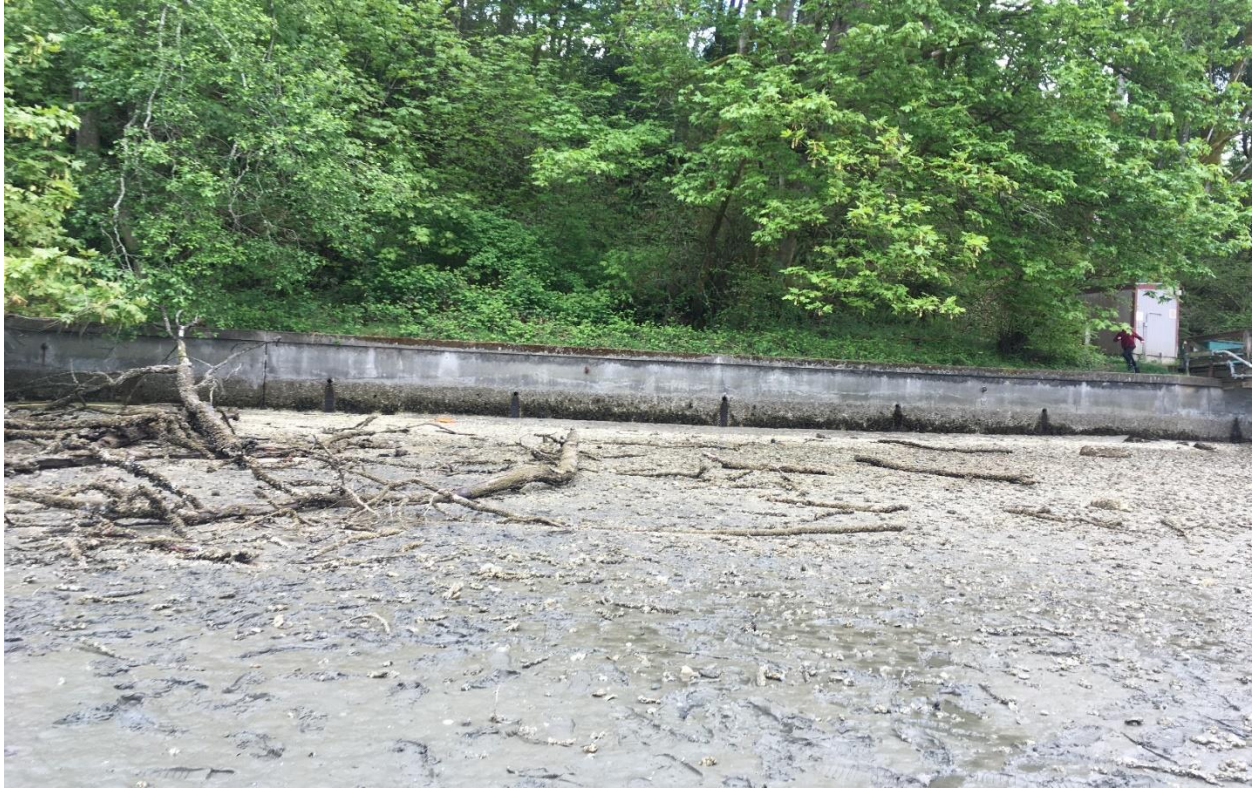
Figure 9a. Dockton Park restoration treatment representative photo 2018.

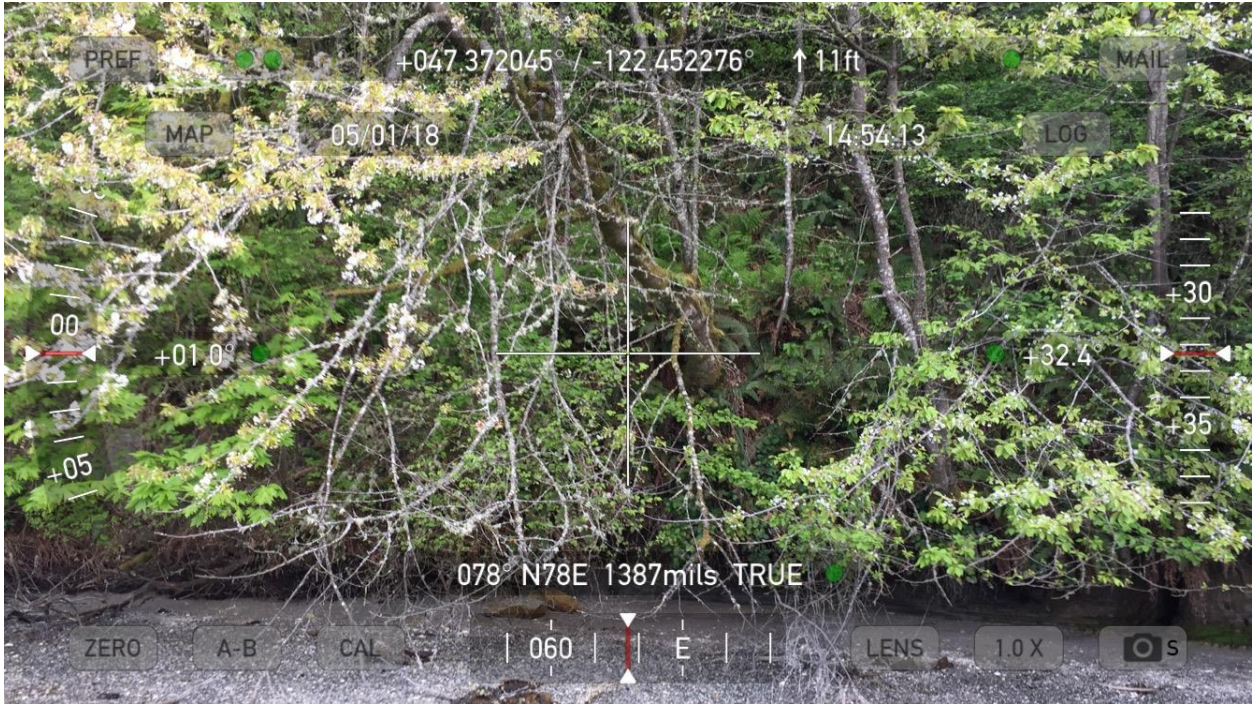
Figure 9b. Dockton Park natural treatment representative photo 2018.

removed by 2022. The uplands are forested and contain many trees that overhang the bulkhead. The armored treatment is to the west on the other side of the boat dock (Figure 9c). It is also concrete and in good repair. The uplands are highly modified for public use and topped with a cement walkway. The armored treatment contains very little overhanging vegetation. The natural treatment is northeast and adjacent to the restoration site. The uplands consist of mixed-coniferous deciduous forest (Figure 9b).

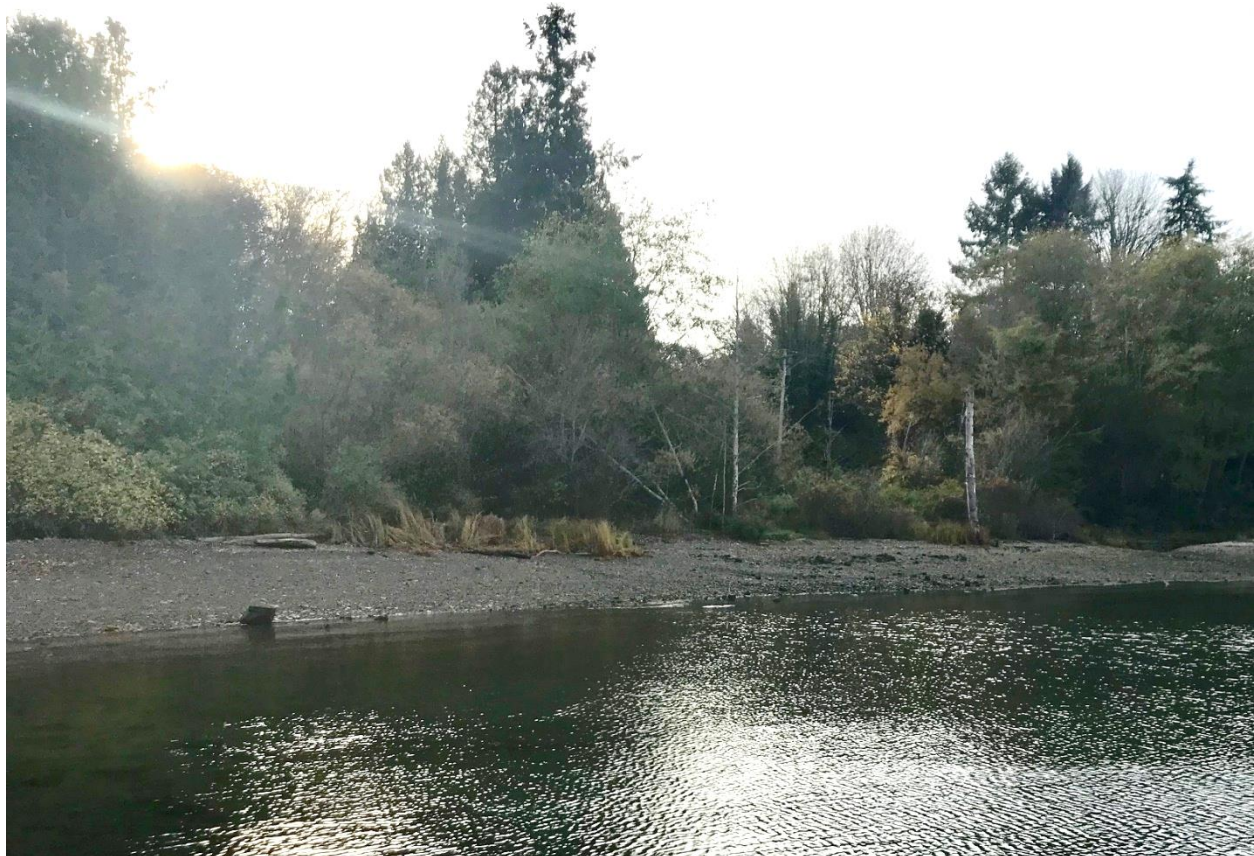
Figure 9d. Previously restored treatment at Dockton, 2018. This treatment was restored in 2013.

There is an additional previously restored treatment that was surveyed in 2016 (restored in 2013; Figure 9d). In this report we compare the natural, restoration (armored) and previously restored treatments. There was not enough data available to include the armored treatment in our analysis.
